**Flood Control Project Maintenance
Levee Inspections**

Fall 2015 Levee Maintenance Deficiency Summary Report

San Joaquin River Basin

Reclamation District No. 2062 Stewart

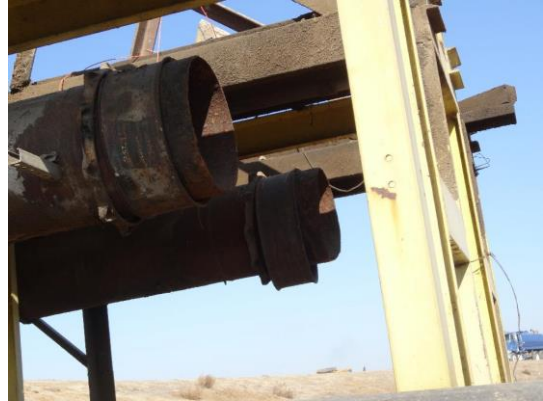
Photo 1 of 3 : UCIP_FA_2015_2078.jpg

LM Start	1.64	Rating **	M	Issue No.	13
LM End	1.64	Issue Type +	En	Location *	WS
Category	Supplemental			GPS Latitude/Longitude	
				Start	End
Item	DWR UCIP Field Study			37.793521 °	37.793521 °
				-121.315348 °	-121.315348 °
DWR ID					
Action/Comments					
Inspector Comments: FS_ID:22807					
DS_ID:19177					
EP_NO: 12679					
FS_HLM: 1.6701					
Repair Type: Non-Urgent					
Crossing Status: Found

WS view: two 16-inch pipes. Pumps were removed. Pumphouse dismantled.

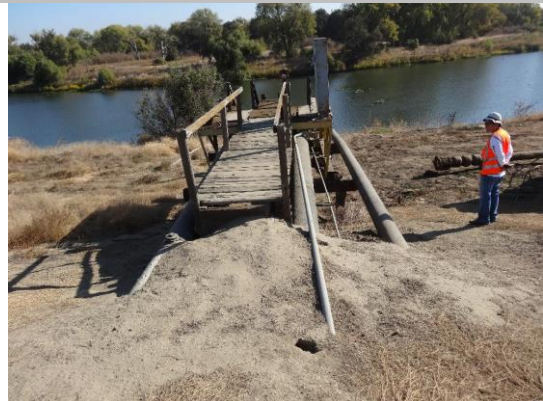
Photo 2 of 3 : UCIP_FA_2015_2079.jpg

WS view: 16-inch pipes on both sides of walkway and 10-inch pipe (on right) away from walkway.

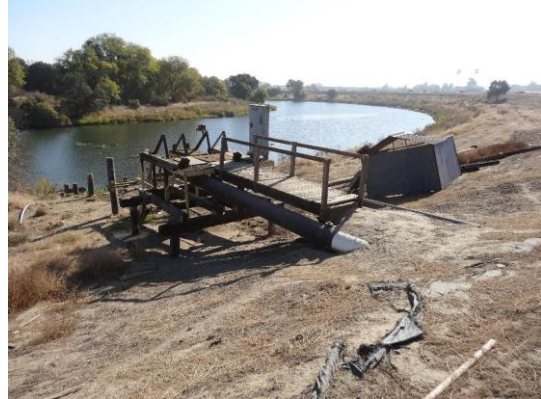
Photo 3 of 3 : UCIP_FA_2015_2080.jpg

LM Start	1.64	Rating **	M	Issue No.	13 (cont)
LM End	1.64	Issue Type +	En	Location *	WS
Category	Supplemental			GPS Latitude/Longitude	
				Start	End
Item	DWR UCIP Field Study			37.793521 °	37.793521 °
				-121.315348 °	-121.315348 °
DWR ID					
Action/Comments					
Inspector Comments: FS_ID:22807					
DS_ID:19177					
EP_NO: 12679					
FS_HLM: 1.6701					
Repair Type: Non-Urgent					
Crossing Status: Found

WS view: pipes, walkway, and dismantled pumphouse (right).

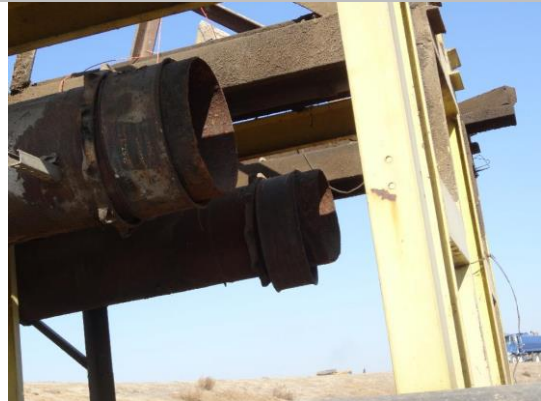
Photo 1 of 3 : UCIP_FA_2015_2081.jpg

LM Start	1.64	Rating **	M	Issue No.	14
LM End	1.64	Issue Type +	En	Location *	WS
Category	Supplemental			GPS Latitude/Longitude	
				Start	End
Item	DWR UCIP Field Study			37.793510 °	37.793510 °
				-121.315345 °	-121.315345 °
DWR ID					
Action/Comments					
Inspector Comments: FS_ID:22809 DS_ID:19183 EP_NO: 12679 FS_HLM: 1.671 Repair Type: Non-Urgent Crossing Status: Found UCIP Comments: - All 3 pipes on landside looks new.- Pumps, pump house, and pipes removed from waterside.- Land development activities going on in this area.- Needs to confirm from LMA or DWR Inspector about the crossing. FIELD_STRUCT_DESC: 2 of 3: Two 16-inch steel pipes, one 8-inch steel pipe, and three electric conduits through the levee 5.0 feet below the crown. Two slant pumps in the pump house on the waterward slope. Siphon breakers on the landward slope. (App. No. 16124) FS Date: 10/22/2013

WS view: two 16-inch pipes under walkway; pumps were removed.

Inspector Comments: FS_ID:22809
 DS_ID:19183
 EP_NO: 12679
 FS_HLM: 1.671
 Repair Type: Non-Urgent
 Crossing Status: Found
 UCIP Comments: - All 3 pipes on landside looks new.- Pumps, pump house, and pipes removed from waterside.- Land development activities going on in this area.- Needs to confirm from LMA or DWR Inspector about the crossing.
 FIELD_STRUCT_DESC: 2 of 3: Two 16-inch steel pipes, one 8-inch steel pipe, and three electric conduits through the levee 5.0 feet below the crown. Two slant pumps in the pump house on the waterward slope. Siphon breakers on the landward slope. (App. No. 16124)
 FS Date: 10/22/2013

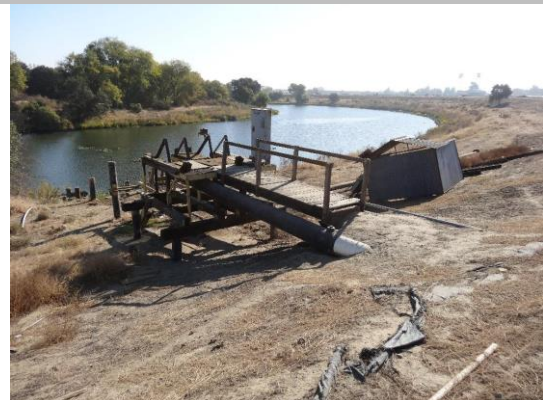
Photo 3 of 3 : UCIP_FA_2015_2095.jpg

WS view: pipes, walkway, and dismantled pumphouse (right).

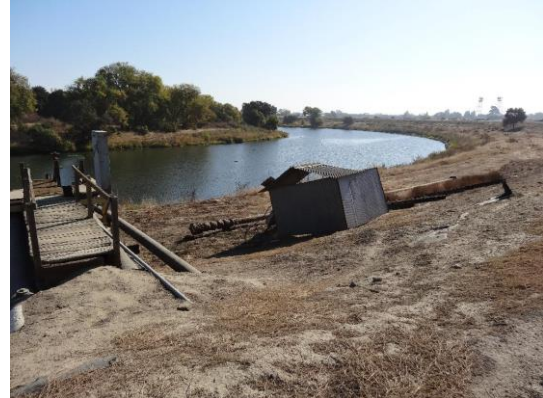
Photo 2 of 3 : UCIP_FA_2015_2097.jpg

LM Start	1.64	Rating **	M	Issue No.	15
LM End	1.64	Issue Type +	En	Location *	WS
Category	Supplemental			GPS Latitude/Longitude	
				Start	End
Item	DWR UCIP Field Study			37.793497 °	37.793497 °
				-121.315340 °	-121.315340 °
DWR ID					
Action/Comments					
Inspector Comments: FS_ID:22810					
DS_ID:19184					
EP_NO: 12679					
FS_HLM: 1.6719					
Repair Type: Non-Urgent					
Crossing Status: Found

WS view: electric conduit and 10-inch pipe (right). Dismantled/removed
pipe and pump house (far right).

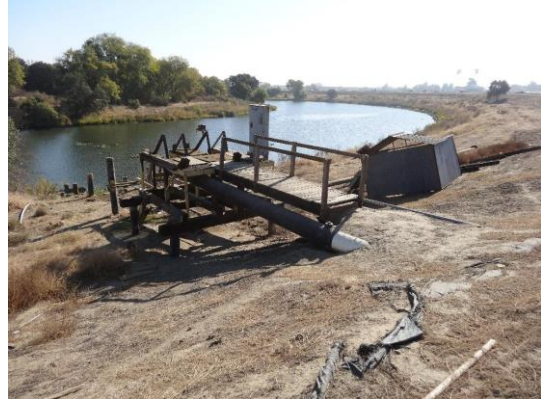
Photo 3 of 3 : UCIP_FA_2015_2098.jpg

LM Start	1.64	Rating **	M	Issue No.	15 (cont)
LM End	1.64	Issue Type +	En	Location *	WS
Category	Supplemental			GPS Latitude/Longitude	
				Start	End
Item	DWR UCIP Field Study			37.793497 °	37.793497 °
				-121.315340 °	-121.315340 °
DWR ID					
Action/Comments					
Inspector Comments: FS_ID:22810					
DS_ID:19184					
EP_NO: 12679					
FS_HLM: 1.6719					
Repair Type: Non-Urgent					
Crossing Status: Found

WS view: pipes, walkway, and dismantled pumphouse (right).

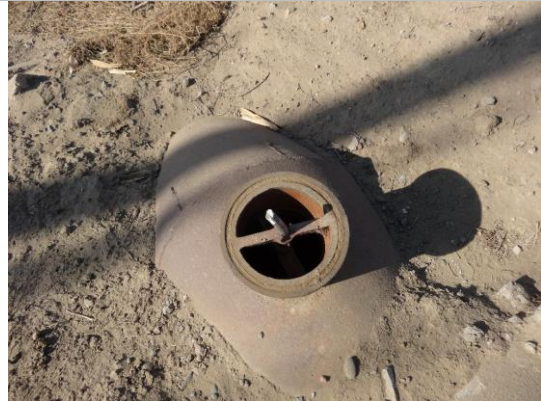
Photo 2 of 3 : UCIP_FA_2015_2155.jpg

Inspector Comments: FS_ID:23110
 DS_ID:24697
 EP_NO: N/A
 FS_HLM: 0.576
 Repair Type: Non-Urgent
 Crossing Status: Found
 UCIP Comments: Found on field with the help of USACE 2012 PI Report. Needs proper abandonment.
 FIELD_STRUCT_DESC: Abandoned 24-inch steel pipe through the levee. Damaged siphon breaker on waterside levee slope. Pump on concrete sump on landside. Service pole on landside levee slope. Pump was disconnected from service pole.
 FS Date: 10/23/2013

WS view: exposed steel pipe and damaged siphon breaker on levee slope.

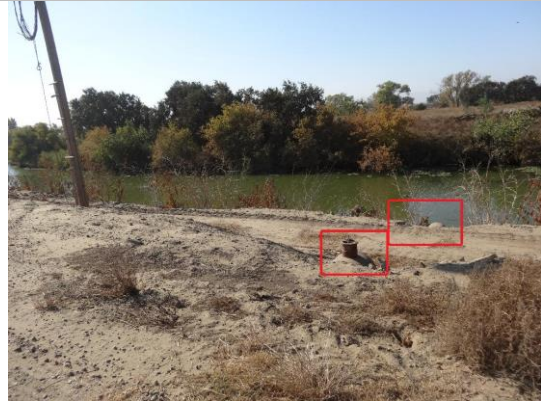
Photo 3 of 3 : UCIP_FA_2015_2156.jpg

LM Start	0.56	Rating **	M	Issue No.	16 (cont)
LM End	0.56	Issue Type +	En	Location *	LS
Category	Supplemental			GPS Latitude/Longitude	
				Start	End
Item	DWR UCIP Field Study			37.784380 °	37.784380 °
				-121.338985 °	-121.338985 °
DWR ID					
Action/Comments					
Inspector Comments: FS_ID:23110					
DS_ID:24697					
EP_NO: N/A					
FS_HLM: 0.576					
Repair Type: Non-Urgent					
Crossing Status: Found

WS view: power pole (left), siphon breaker (marked- left), and steel pipe (right) on levee slope.

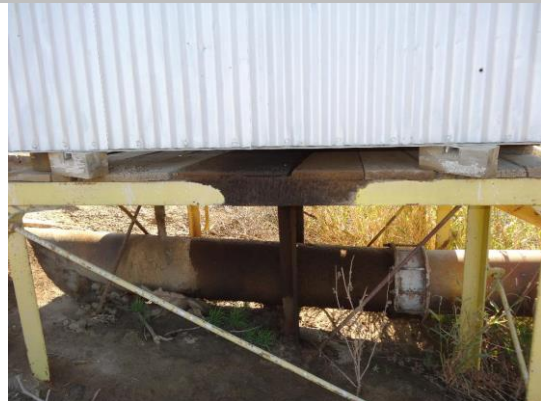
Photo 1 of 3 : UCIP_FA_2015_0686.jpg

LM Start	0.75	Rating **	M	Issue No.	17
LM End	0.75	Issue Type +	En	Location *	LS
Category	Supplemental			GPS Latitude/Longitude	
				Start	End
Item	DWR UCIP Field Study			37.786130 °	37.786130 °
				-121.341564 °	-121.341564 °
DWR ID					
Action/Comments					
Inspector Comments: FS_ID:23181 DS_ID:19192 EP_NO: 12427 FS_HLM: 0.765 Repair Type: Non-Urgent Crossing Status: Found UCIP Comments: - no siphon breaker found- levee toe erosion under walkway on waterside.- erosion around concrete standpipe on landside- may be base of the standpipe was leaking. FIELD_STRUCT_DESC: 18-inch pipe through the levee 4.4 feet below the crown, pump house on the waterward slope, metal walkway from the pump house to the crown. Power pole on waterside. Flap gate and concrete distribution box on the landward slope. (App. No. 12427) FS Date: 10/23/2013

WS view: oil leakage from slant pump. Pipe under pump house.

Inspector Comments: FS_ID:23181
 DS_ID:19192
 EP_NO: 12427
 FS_HLM: 0.765
 Repair Type: Non-Urgent
 Crossing Status: Found
 UCIP Comments: - no siphon breaker found- levee toe erosion under walkway on waterside.- erosion around concrete standpipe on landside- may be base of the standpipe was leaking.
 FIELD_STRUCT_DESC: 18-inch pipe through the levee 4.4 feet below the crown, pump house on the waterward slope, metal walkway from the pump house to the crown. Power pole on waterside. Flap gate and concrete distribution box on the landward slope. (App. No. 12427)
 FS Date: 10/23/2013

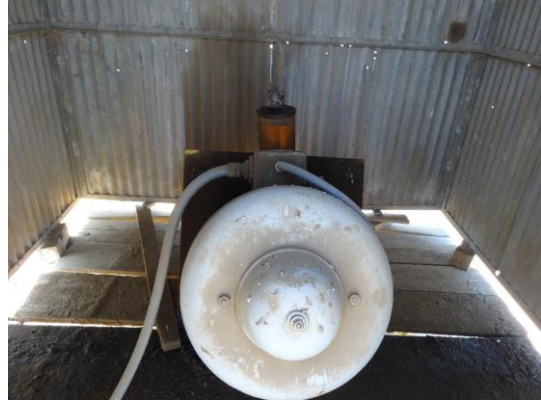
Photo 2 of 3 : UCIP_FA_2015_0687.jpg

WS view: leaky slant pump in pumphouse on levee slope.

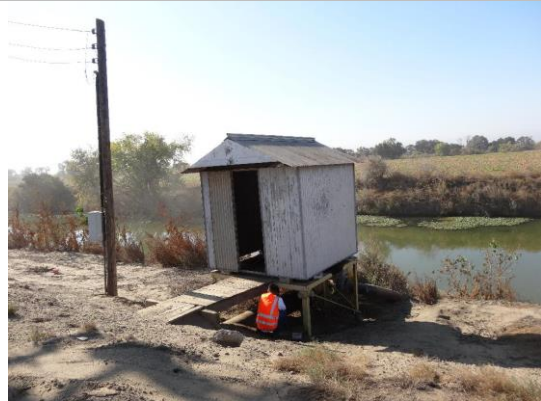
Photo 3 of 3 : UCIP_FA_2015_0688.jpg

WS view: pipe, walkway, service pole, and pumphouse on levee slope.

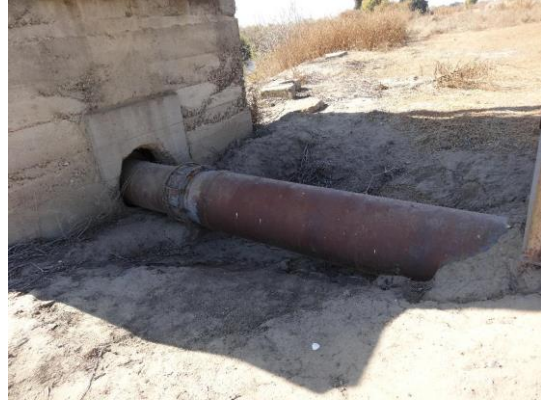
Photo 1 of 3 : UCIP_FA_2015_2151.jpg

LM Start	1.37	Rating **	M	Issue No.	18
LM End	1.37	Issue Type +	En	Location *	LS
Category	Supplemental			GPS Latitude/Longitude	
				Start	End
Item	DWR UCIP Field Study			37.791821 °	37.791821 °
				-121.350448 °	-121.350448 °
DWR ID					
Action/Comments					
Inspector Comments: FS_ID:23062					
DS_ID:19193					
EP_NO: N/A					
FS_HLM: 1.4002					
Repair Type: Non-Urgent					
Crossing Status: Found

WS view: exposed steel pipe under walkway. Soil erosion under walkway. This may be due to leaky pipe joint.

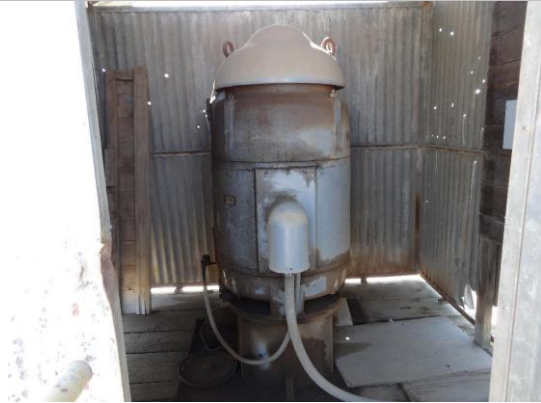
Photo 2 of 3 : UCIP_FA_2015_2152.jpg

WS view: leaky pump and control box in pumphouse.

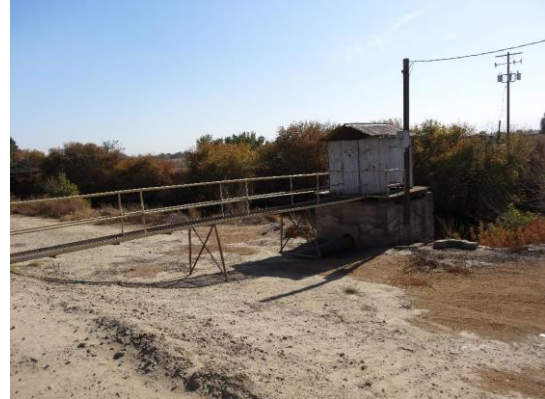
Photo 3 of 3 : UCIP_FA_2015_2153.jpg

LM Start	1.37	Rating **	M	Issue No.	18 (cont)
LM End	1.37	Issue Type +	En	Location *	LS
Category	Supplemental			GPS Latitude/Longitude	
				Start	End
Item	DWR UCIP Field Study			37.791821 °	37.791821 °
				-121.350448 °	-121.350448 °
DWR ID					
Action/Comments					
Inspector Comments: FS_ID:23062 DS_ID:19193 EP_NO: N/A FS_HLM: 1.4002 Repair Type: Non-Urgent Crossing Status: Found

WS view: pipe, walkway, and pumphouse on levee berm. Service pole on waterside.

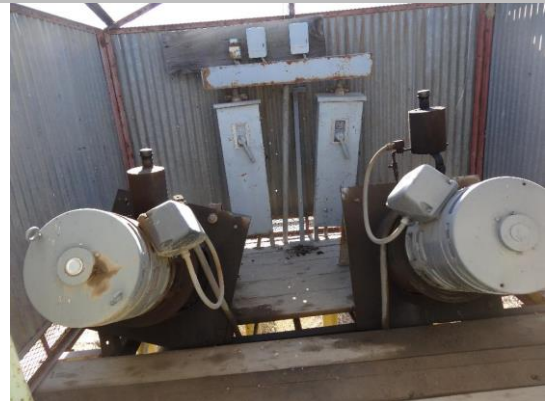
Photo 1 of 3 : UCIP_FA_2015_0555.jpg

LM Start	1.64	Rating **	U	Issue No.	19
LM End	1.64	Issue Type +	En	Location *	LS
Category	Supplemental			GPS Latitude/Longitude	
				Start	End
Item	DWR UCIP Field Study			37.794009 °	37.794009 °
				-121.354417 °	-121.354417 °
DWR ID					
Action/Comments					
Inspector Comments: FS_ID:23061 DS_ID:19194 EP_NO: 4305 FS_HLM: 1.6693 Repair Type: Urgent Crossing Status: Found UCIP Comments: - missing roof in pump house.- no protection for siphon breaker- huge erosion under pumphouse and levee slope on waterside. FIELD_STRUCT_DESC: 1 of 2: Two 18-inch pipes through the levee 4.8 feet below the crown. Pump house on the waterward slope. Siphon breaker on the landward shoulder. Power pole on the landward shoulder. Concrete distribution box at the toe of the landward slope. (App. No. 4305) FS Date: 10/22/2013

WS view: two leaky slant pumps in pumphouse with missing roof.

Inspector Comments: FS_ID:23061
 DS_ID:19194
 EP_NO: 4305
 FS_HLM: 1.6693
 Repair Type: Urgent
 Crossing Status: Found
 UCIP Comments: - missing roof in pump house.- no protection for siphon breaker- huge erosion under pumphouse and levee slope on waterside.
 FIELD_STRUCT_DESC: 1 of 2: Two 18-inch pipes through the levee 4.8 feet below the crown. Pump house on the waterward slope. Siphon breaker on the landward shoulder. Power pole on the landward shoulder. Concrete distribution box at the toe of the landward slope.
 (App. No. 4305)
 FS Date: 10/22/2013

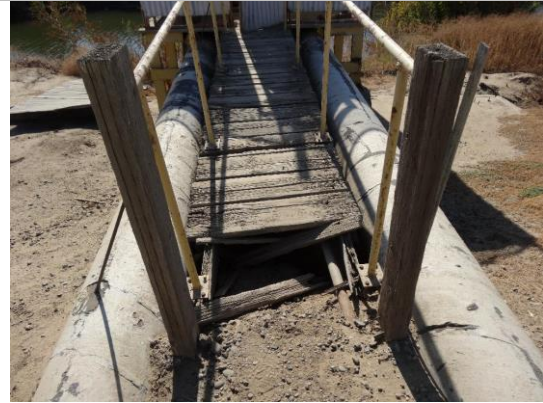
Photo 2 of 3 : UCIP_FA_2015_2149.jpg

WS view: walkway to pumphouse. Walkway in poor condition.

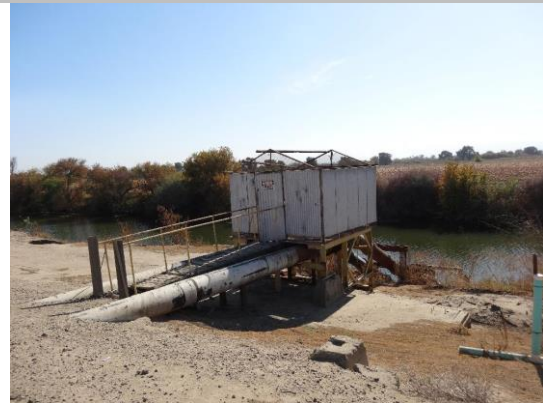
Photo 3 of 3 : UCIP_FA_2015_2150.jpg

WS view: pipes, walkway, and pumphouse with missing roof (right).

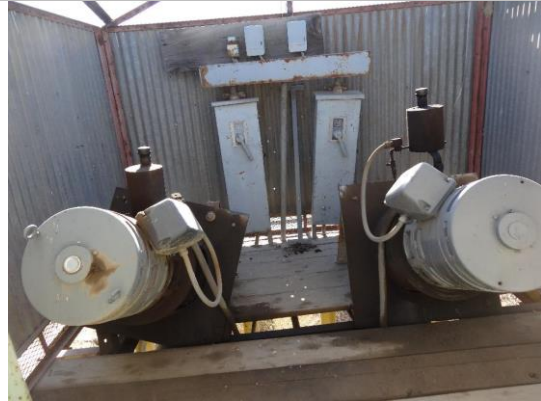
Photo 1 of 3 : UCIP_FA_2015_1695.jpg

LM Start	1.64	Rating **	U	Issue No.	20
LM End	1.64	Issue Type +	En	Location *	LS
Category	Supplemental			GPS Latitude/Longitude	
				Start	End
Item	DWR UCIP Field Study			37.794014 °	37.794014
				-121.354434 °	-121.354434
DWR ID					
Action/Comments					
Inspector Comments: FS_ID:23059					
DS_ID:19197					
EP_NO: 4305					
FS_HLM: 1.6704					
Repair Type: Urgent					
Crossing Status: Found

WS view: two leaky slant pumps in pumphouse with missing roof.

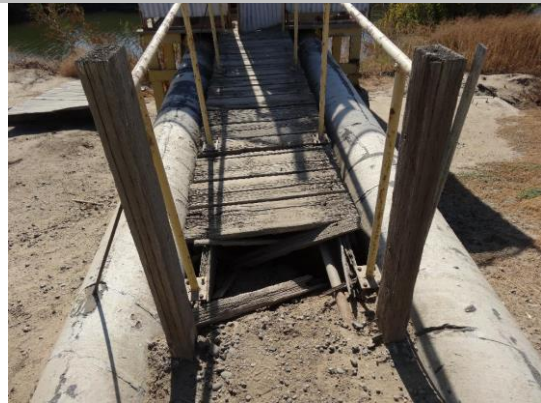
Photo 2 of 3 : UCIP_FA_2015_1696.jpg

WS view: walkway in poor condition, to pumphouse.

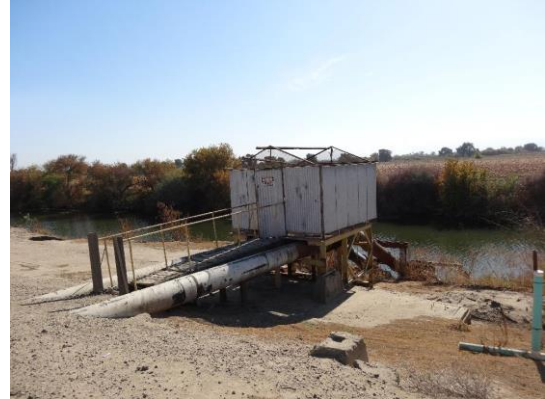
Photo 3 of 3 : UCIP_FA_2015_1697.jpg

LM Start	1.64	Rating **	U	Issue No.	20 (cont)	
LM End	1.64	Issue Type +	En	Location *	LS	
Category	Supplemental			GPS Latitude/Longitude		
				Start	End	
Item	DWR UCIP Field Study			37.794014 °	37.794014	
				-121.354434 °	-121.354434	
DWR ID						
Action/Comments						
Inspector Comments: FS_ID:23059						
DS_ID:19197						
EP_NO: 4305						
FS_HLM: 1.6704						
Repair Type: Urgent						
Crossing Status: Found

WS view: pipes, walkway, and pumphouse with missing roof (right).

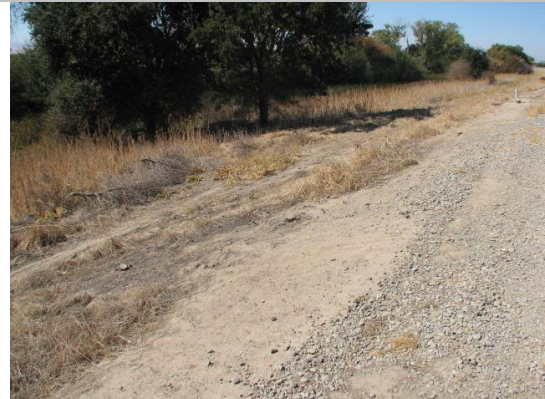
Photo 1 of 1 : FA_2015_RD2062_310_3_20150910_00001.jpg

Three small stumps on levee slope.

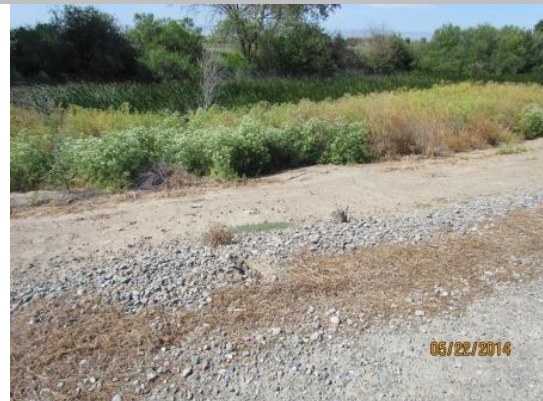
Photo 1 of 1 : FA_2015_RD2062_310_15_20150910_00005.jpg

View of the tree stumps on the waterside levee slope.

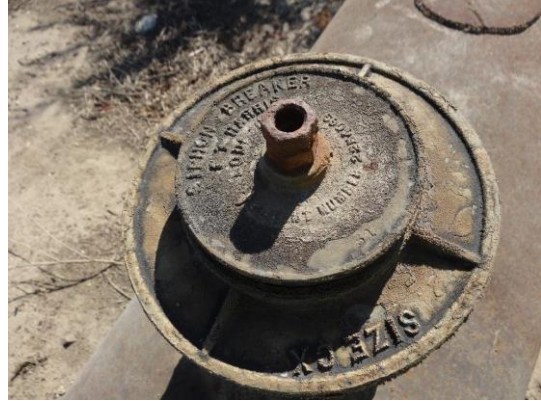
Photo 1 of 3 : UCIP_FA_2015_2212.jpg

Inspector Comments: FS_ID:23304
 DS_ID:19199
 EP_NO: 11524
 FS_HLM: 3.302
 Repair Type: Non-Urgent
 Crossing Status: Found
 UCIP Comments: - waterside pipe immersed into channel water. - most of the pipe on landside exposed and siphon breaker on waterside not protected.
 FIELD_STRUCT_DESC: 1 of 3: One of 2x24-inch pipes through the levee 2.0 feet below the crown. 18-inch pipe through the levee 4.0 feet below the crown. Siphon breakers on waterward slope. Pump on steel platform in drainage ditch, 350 ft. from levee center off the the landward berm. (App. No. 11524)
 FS Date: 10/22/2013

WS view: leaky siphon breaker on levee slope.

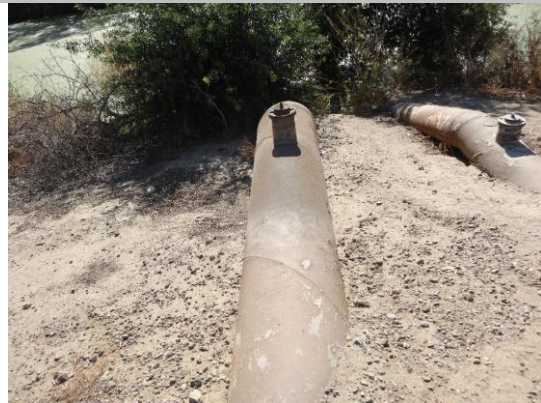
Photo 2 of 3 : UCIP_FA_2015_2213.jpg

WS view: 24-inch steel pipe (left) with siphon breaker on levee slope. 18-inch pipe on right.

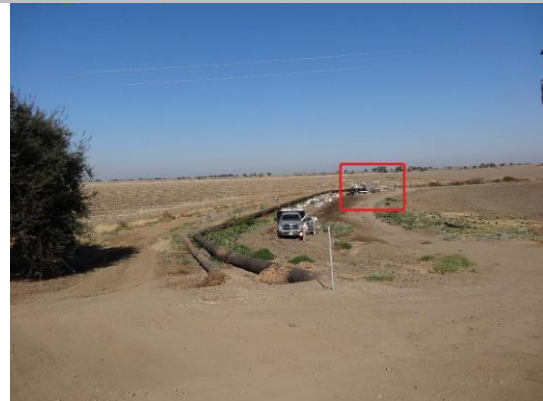
Photo 1 of 3 : UCIP_FA_2015_2023.jpg

LM Start	3.24	Rating **	M	Issue No.	22
LM End	3.24	Issue Type +	En	Location *	WS
Category	Supplemental			GPS Latitude/Longitude	
				Start	End
Item	DWR UCIP Field Study			37.804777 °	37.804777 °
				-121.379704 °	-121.379704 °
DWR ID					
Action/Comments					
Inspector Comments: FS_ID:23023 DS_ID:19198 EP_NO: 11524 FS_HLM: 3.3033 Repair Type: Non-Urgent Crossing Status: Found UCIP Comments: - 18-inch pipe bifurcated near the pump and two gate valves installed.- waterside pipe immersed into channel water.- most of the pipe on landside exposed and siphon breaker on waterside not protected. FIELD_STRUCT_DESC: 2 of 3: 18-inch pipe through the levee 4.0 feet below the crown. 2x24-inch pipes through the levee 2.0 feet below the crown. Siphon breakers on waterward slope. Pump on steel platform in drainage ditch, 350 ft. from levee center off the the landward berm. (App. No. 11524) FS Date: 10/22/2013

LS view: overview of exposed pipes and pump station (marked- right) 350 ft from levee center.

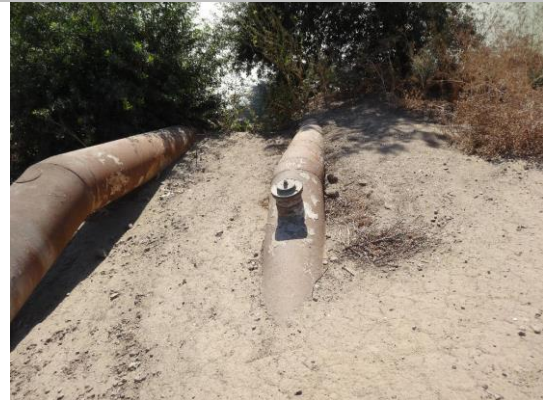
Photo 3 of 3 : UCIP_FA_2015_2025.jpg

WS view: exposed 18-inch pipe with siphon breaker on levee slope.
Exposed 24-inch pipe (left).

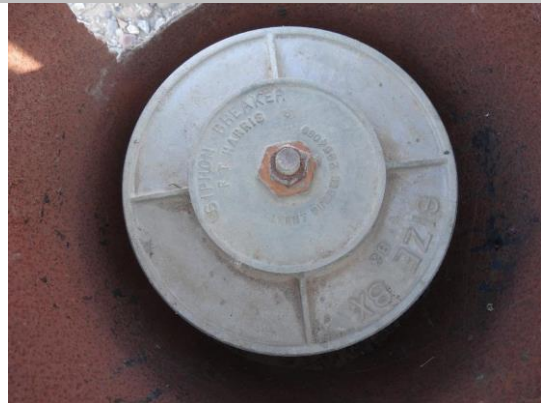
Photo 2 of 3 : UCIP_FA_2015_2216.jpg

WS view: closer view of siphon breaker in steel pipe riser on levee slope.

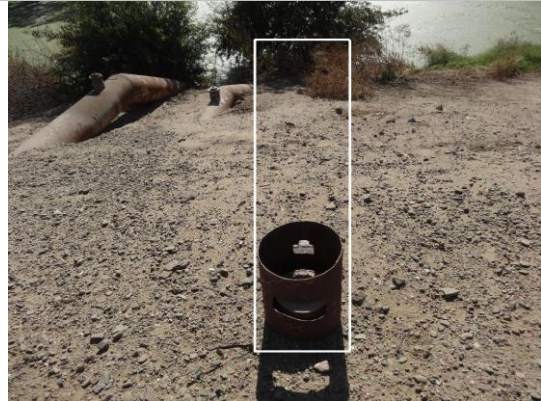
Photo 3 of 3 : UCIP_FA_2015_2217.jpg

WS view: siphon breaker in steel pipe riser on levee slope.

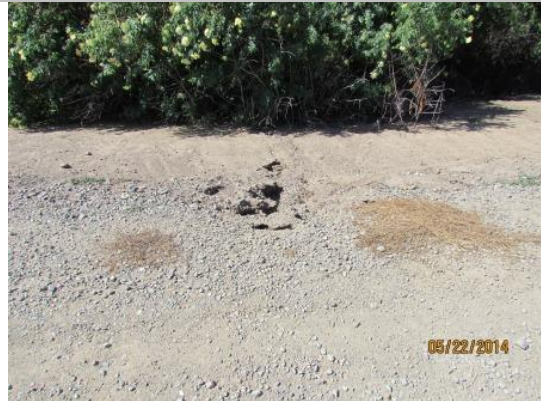
Photo 1 of 1 : FA_2015_RD2062_310_8_20150910_00002.jpg

View of the erosion from surface runoff on the waterside levee slope.

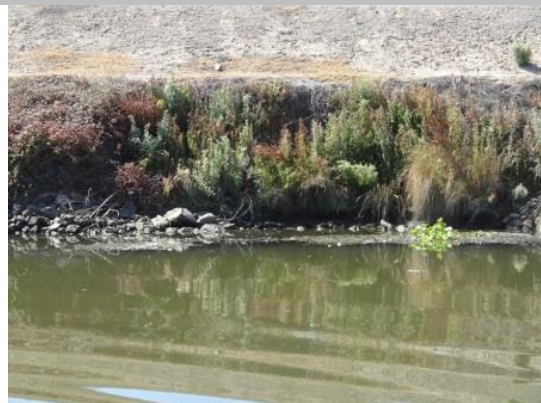
Photo 3 of 3 : SJR2015_RD2062U03RM29.93_3.jpg

Front view of the erosion.

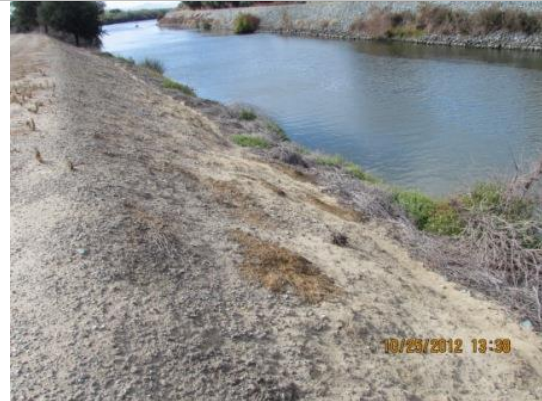
Photo 1 of 1 : FA_2015_RD2062_311_3_20150910_00003.jpg

View of tree stumps on waterside slope.

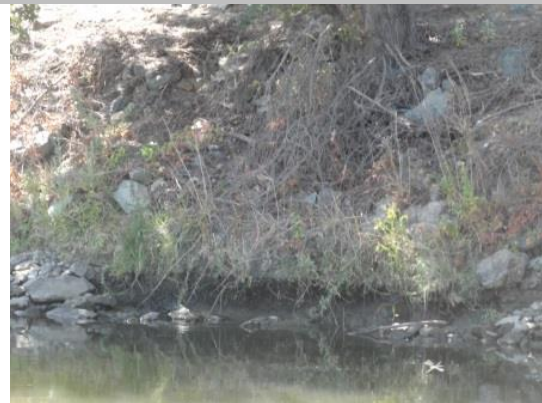
Photo 1 of 3 : SJR2015_RD2062U03RM30.02_4.jpg

Close view of the site. Note the vegetation.

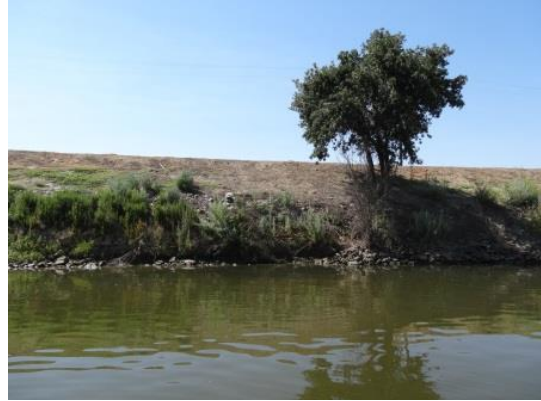
Photo 2 of 3 : SJR2015_RD2062U03RM30.19_11.jpg

View of the pocket erosion and the tree.

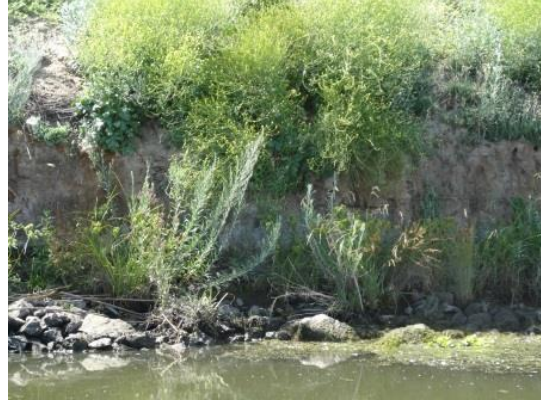
Photo 3 of 3 : SJR2015_RD2062U03RM30.19_2.jpg

Close view of the pocket erosion.

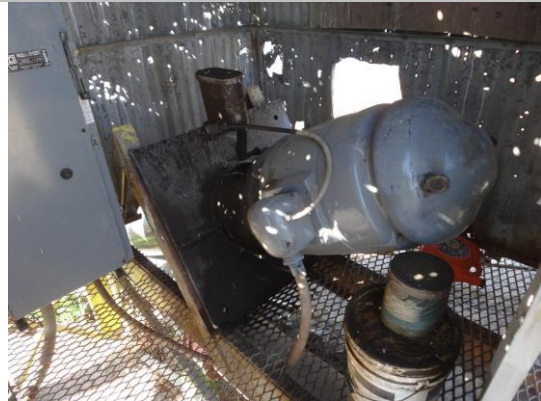
Photo 1 of 3 : UCIP_FA_2015_2218.jpg

WS view: slant pump in pumphouse on levee slope.

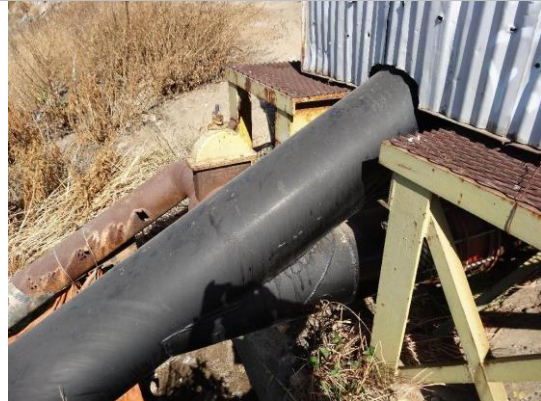
Photo 2 of 3 : UCIP_FA_2015_2219.jpg

WS view: pump house on levee slope and holes-pits on corroded overflow pipe (left).

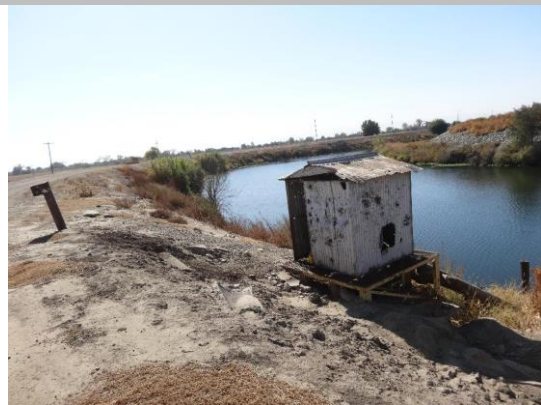
Photo 3 of 3 : UCIP_FA_2015_2220.jpg

WS view: pump house on levee slope and soil erosion on levee slope.

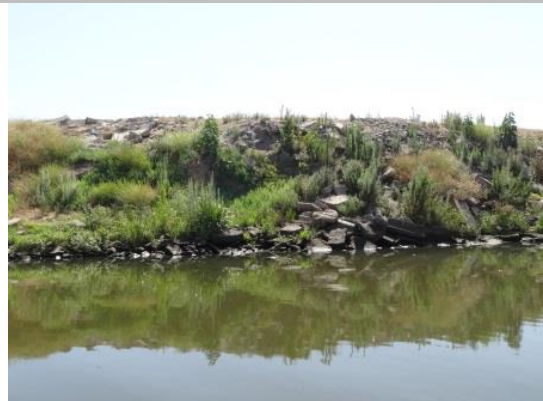
Photo 2 of 3 : SJR2015_RD2062U03RM30.43_3.jpg

Front view of the site. Previously placed rip rap slipped, exposing the underlying soils and creating a pocket.

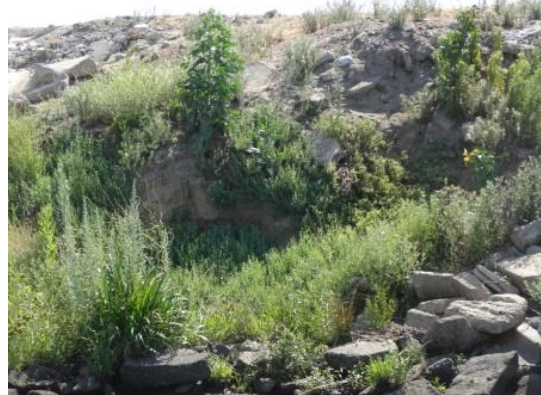
Photo 3 of 3 : SJR2015_RD2062U03RM30.43_4.jpg

Front view of the site. Rip rap no longer adequately protecting levee slope.

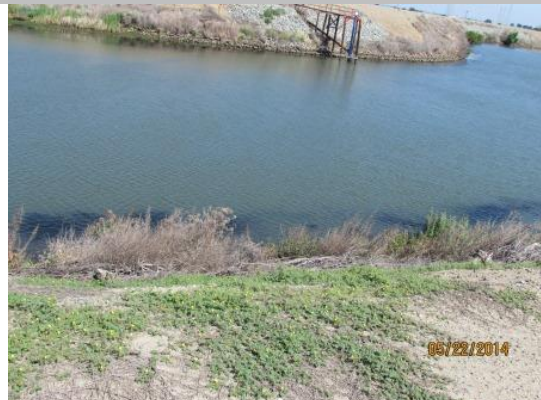
Photo 1 of 1 : FA_2015_RD2062_311_12_20150910_00012.jpg

View of the tree stumps on the waterside levee slope.

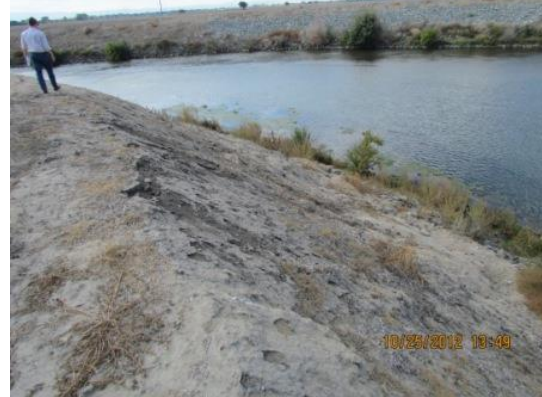
Photo 1 of 2 : FA_2015_RD2062_311_11_20150910_00011.jpg

View of slope erosion from foot traffic.

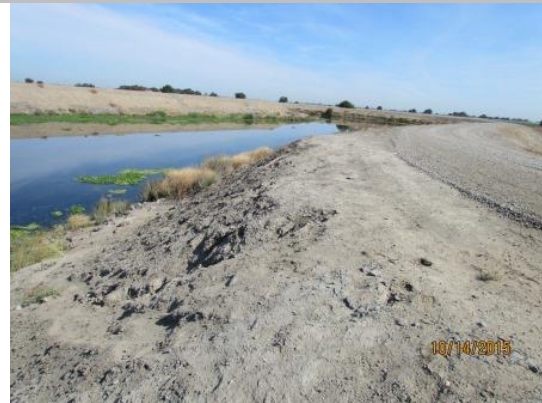
Photo 2 of 2 : FA_2015_RD2062_311_11_20151026_00028.jpg

View of cracking at waterside levee hinge.

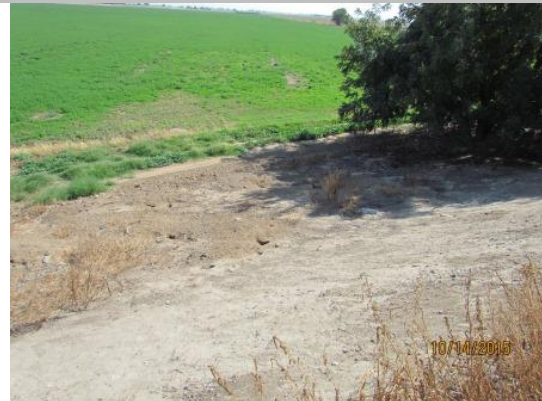
Photo 1 of 1 : FA_2015_RD2062_311_34_20151026_00027.jpg

View of the rodent burrows at the landside levee toe.

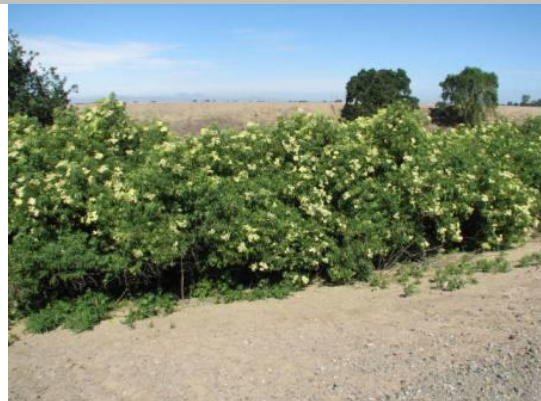
Photo 1 of 1 : FA_2015_RD2062_311_18_20150910_00015.jpg

05/11/2011 Elderberry bush on water side slope.

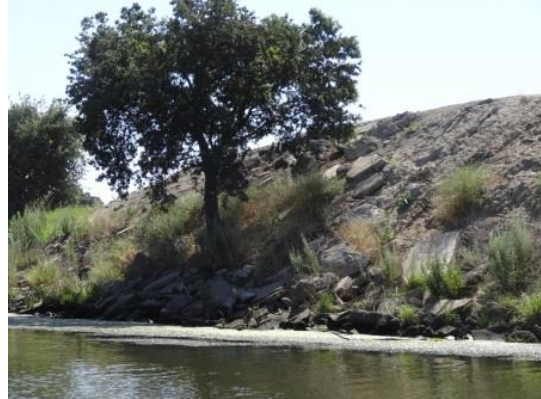
Photo 1 of 3 : SJR2015_RD2062U03RM31.28_11.jpg

Front view of the site. Note existing broken concrete on the upper slope as well as on the lower slope and at the toe.

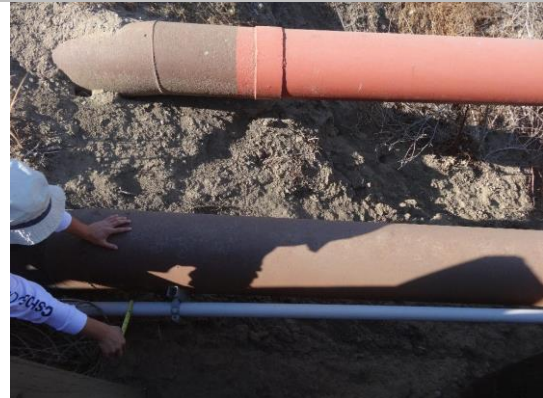
Photo 2 of 3 : UCIP_FA_2015_2225.jpg

WS view: exposed steel pipes and an electric conduit on levee slope.

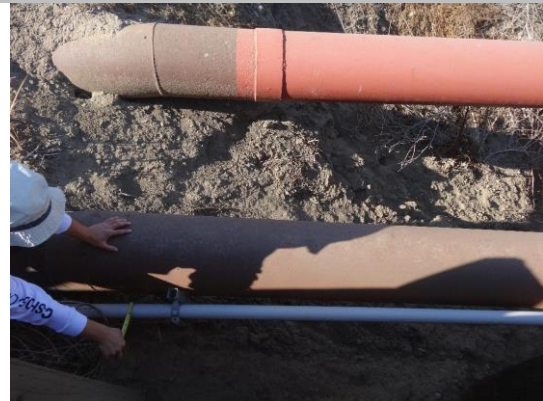
Photo 1 of 3 : UCIP_FA_2015_2101.jpg

WS view: exposed steel pipes and a electric conduit on levee slope.

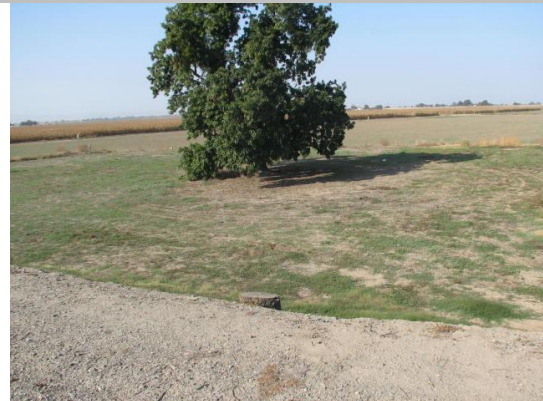
Photo 1 of 1 : FA_2015_RD2062_311_7_20150910_00006.jpg

10/21/2011 Photo taken the next day. Stump can be seen in the lower center of the photo.

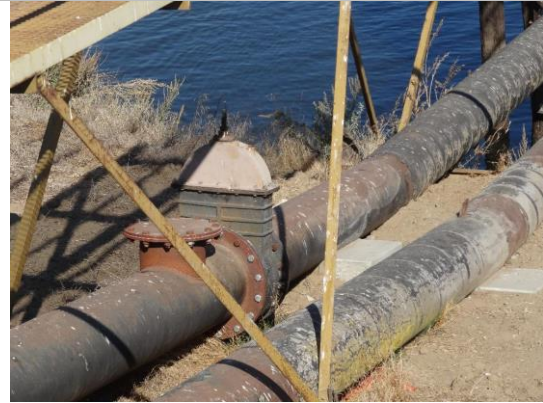
Photo 2 of 3 : UCIP_FA_2015_2177.jpg

WS view: two 16-inch pipes under walkway. Gate valve without handle on one of the pipes.
